Unconventional Implant Placement Through Impacted Maxillary Canine – A Case Report

dr Ivona Bjenjaš, Dental office BGD Osmeh, Belgrade, Serbia

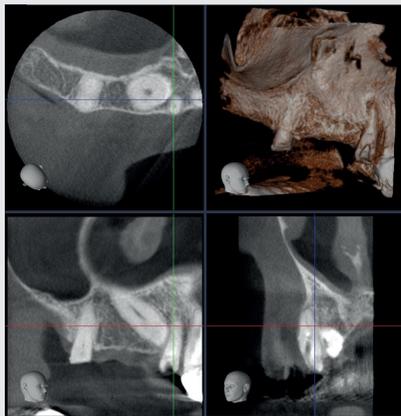
Figure 1 – CBCT small FOV teeth 15-11

Dental status was taken. To reduce the patient x-ray exposure following ALARA recommendation only small FOV on CBCT was done. The impacted right upper canine was discovered. Patient knew about it, but it was completely asymptomatic for years and no other surrounding pathology couldn't be seen on CBCT (Figure 1). Extraction of the impacted tooth was avoided because of expected massive bone loss and possible complications (Figure 2). The tooth 12 was extracted. There was no buccal plate after extraction, so this site was excluded for immediate implant placement. Two C-Tech implants were placed through the impacted tooth in region 13 (EL 3,5x11) and 14 (EL 3,5x9) (Figure 3). Primary stability was achieved on 60N/cm. The wound was sutured with 4,0 Nylon.

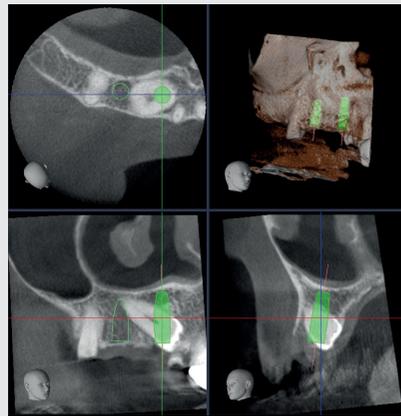
Figure 2 – Implant planning on CBCT

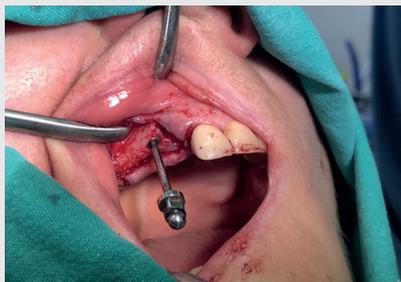
Figure 3 - Implantation

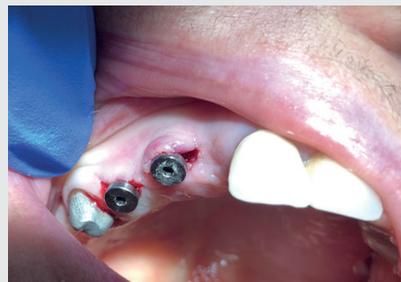
Figure 7 – Healing caps

No postoperative pain, swelling or bleeding was reported by the patient. After seven days sutures were removed, the wound healing was uneventful. Tooth 15 was treated and CoCrMo post was made. After four months implants were uncovered without any difficulties and healing caps were placed (Figure 7). Patient was prosthetically rehabilitated with E-max Cad bridge (Figure 8)

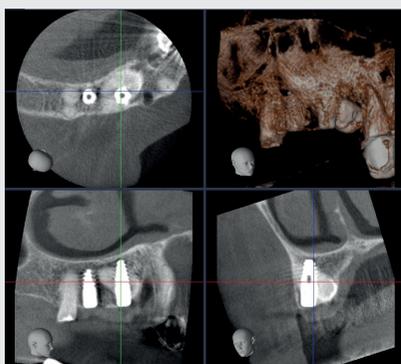
Figure 4 – Control CBCT small FOV

Control CBCT was taken, expected positions of implants were achieved (Figures 4, 5, 6). Patient was prescribed with antibiotic therapy Sinacillin 0.5g 3x1 for seven days and Ibuprofen 0.4g if needed.

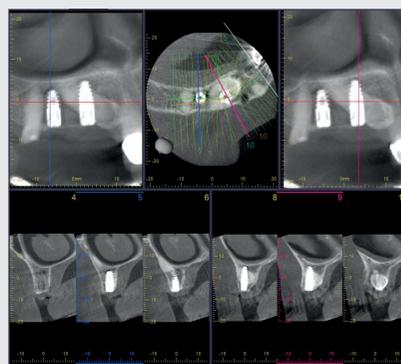
Figure 5 – Control CBCT small FOV

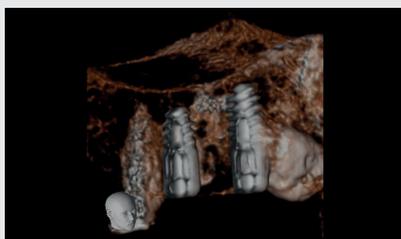
Figure 6 – CBCT small FOV slice along Y plane

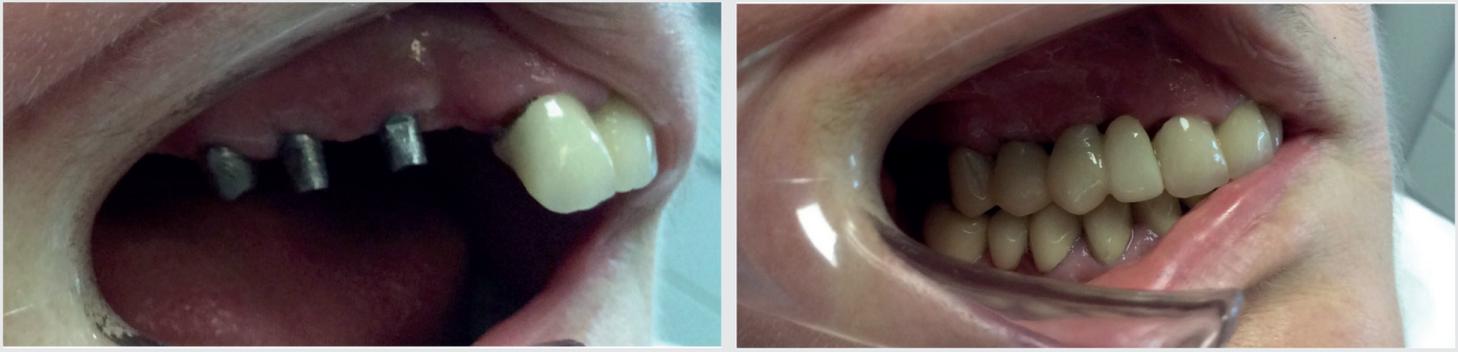
Figure 8 – Definitive restoration
